<b>Technical Service Bulletin</b>	<b>Transaction No:</b>	2015173/27
<b>46-19-02 - Brake Disc, Vibration / Pulsation (U.S. Only)</b>		<b>Release date:</b>	10/17/2019

## Condition

When applying the brakes at highway speeds the following symptoms may occur:

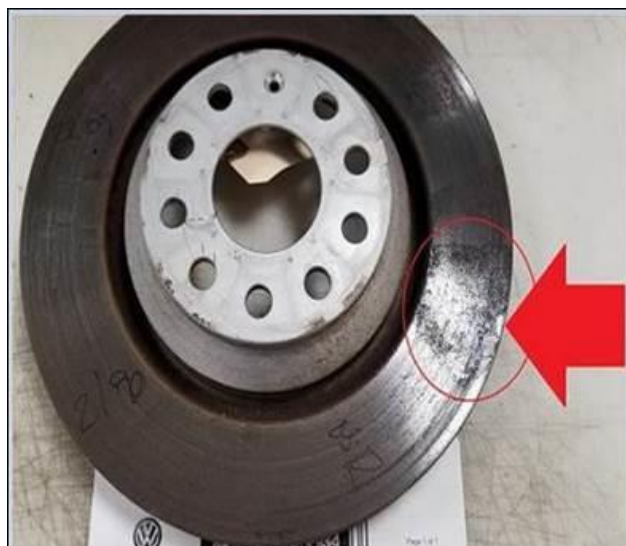
Figure 11: Brake pad imprint.

Brake Discs showing any of the above described conditions are **NOT** serviceable. Parts must be replaced in accordance with the Volkswagen Warranty Policy and Procedure Manual.
