<b>Technical Service Bulletin</b>	<b>Transaction No:</b>	2015173/27
<b>46-19-02 - Brake Disc, Vibration / Pulsation (U.S. Only)</b>		<b>Release date:</b>	10/17/2019

## Condition

When applying the brakes at highway speeds the following symptoms may occur:

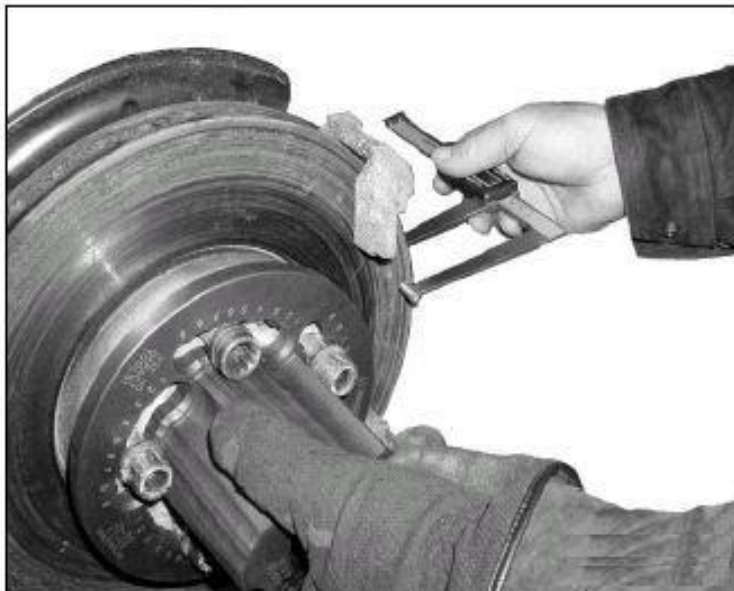
- Re-measure Brake Disc thickness in 4 locations using either the Pro Cut International™ disc thickness measuring tool Part No. 50-902 or the Hunter Engineering Company disc thickness measuring tool Part No. 25-99-2. If recorded Brake Disc measurement is less than the minimum thickness, the Brake Disc **MUST** be replaced.

Technician must record the final thickness measurements after machining on the back of the repair order.

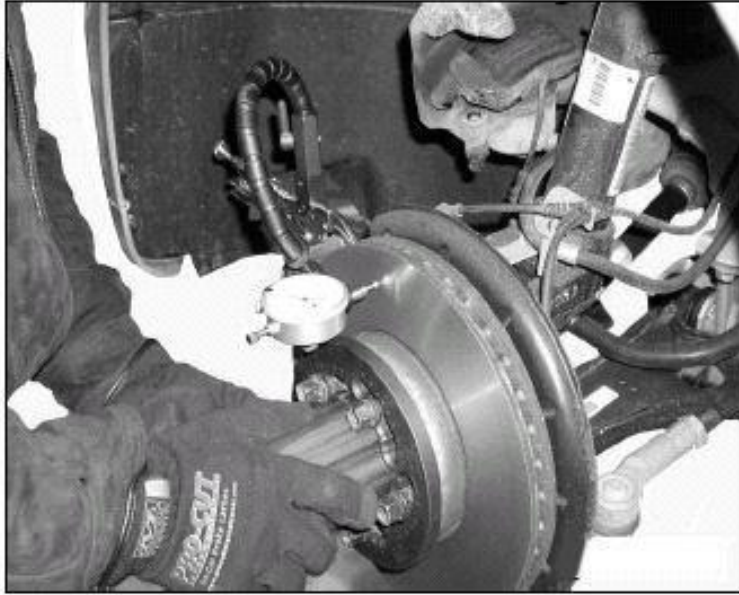
- Measure Brake Disc lateral run out using Pro Cut Disc Lateral run out measuring kit Part No. 50-700FC or the Hunter Disc Lateral run out measuring kit Part No. 25-128-2 with a dial indicator.
- Run out must not exceed 0.1mm after machining.
- If Brake Disc exceed the 0.1mm specification after machining replace the applicable Brake Discs.
