# BRAKE & FRONT END

## Brake Job: Preemptive Diagnostics

## Preemptive Diagnostics

Solving Pulsation Complaints *Before* They Happen

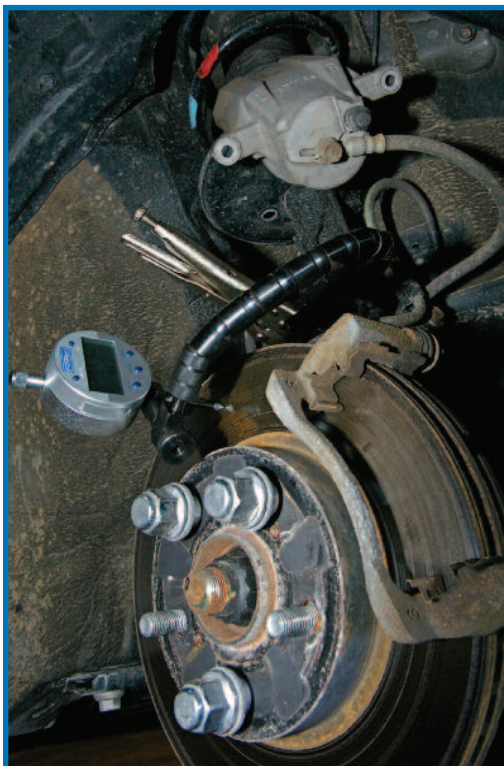
Let’s say the vehicle had .003” of lateral runout when measured at the outside face of the rotor. If this vehicle is riding on 205/55R16 tires, in one mile, the high-spot with .003” of runout goes past the caliper approximately 836 times. Over 6,000 miles, that spot on the rotor will go past the pads more than 5 million times! Every time this spot passes the pads, a little bit of the rotor’s material is removed. Over 5 million revolutions, enough material is removed to create a thickness variation that can be felt by the driver.

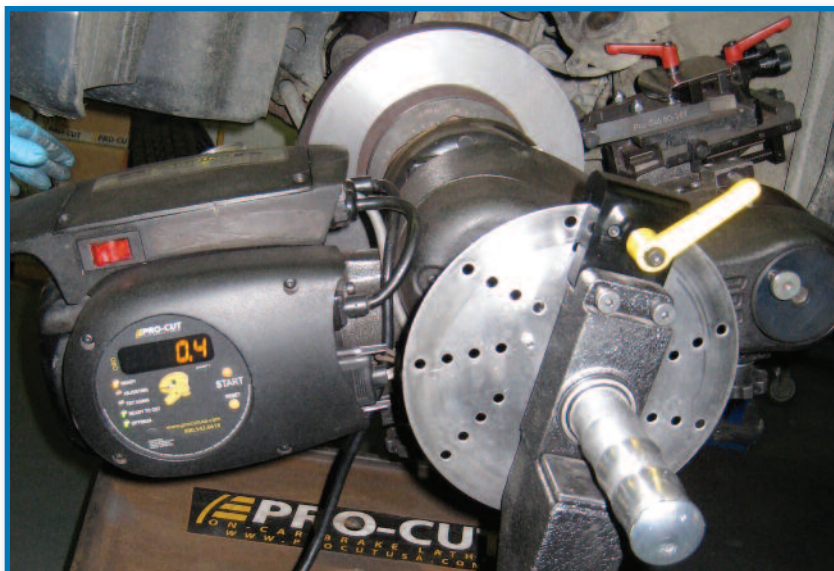
Under these conditions, the caliper will “follow” the runout. The caliper housing will move in and out in relation to the runout. This movement will not cause the caliper piston to move. This is a key point to understand. No piston movement results in no fluid movement in the hydraulic system. If there is no fluid movement, the brake pedal won’t move or pulsate. So, a key point to understand is runout generally does NOT cause pulsation. Runout causes thickness variation that leads to pulsation problems.
